SIDNEY RESOURCES CORPORATION
LUCKY BEN MINE GROUP

Third Quarter Disclosure Report FY2015

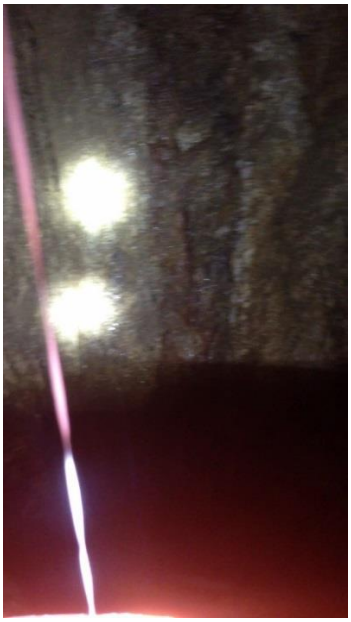
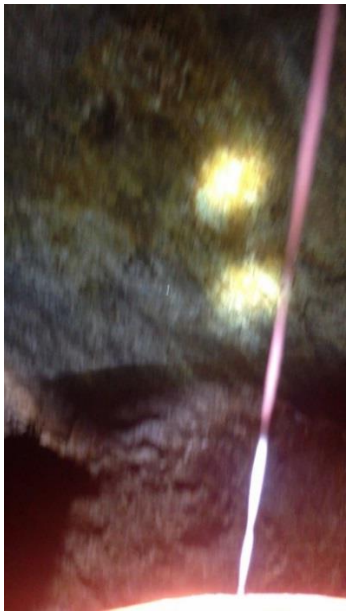
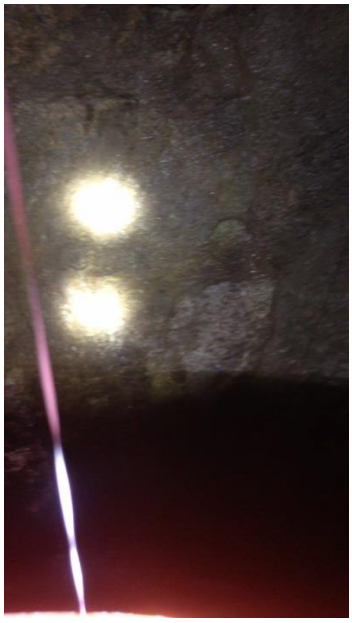
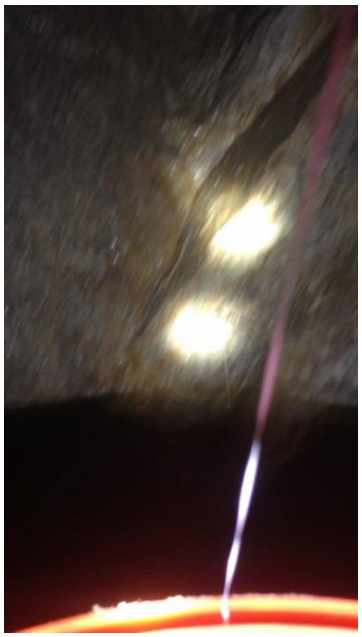
The main vein structure of the Lucky Ben and Lucky Ben extension have been staked from the Adit toward the northeast end of the property. It is along this line where the majority of future trenching work and sampling will take place. During our assessment of the surface along the vein structure we located three caved raises and an open raise. Utilizing technology constructed on sight using an IPhone and two miner lights we were able to complete a video recording of the rise all the way to the tunnel floor. The floor of the tunnel is approximately 210 feet below the surface.

During our video assessment we were able to set the recording equipment on the tunnel floor and found the tunnel floor was dry at this time. Prior to this discovery we were concerned about the volume of water that may have accumulated behind the cave in towards the Adit. Another positive aspect of finding the open raise is knowing that the tunnel will have decent ventilation once the tunnel is opened. The following pictures are of the vein structure taken from the video as we lowered the recorder to the tunnel floor.

Trenching and sampling will be completed along the vein line between the caved raises and the open raise. We are planning on completing this work before the end of the season. In addition to sampling of this area we will conduct sampling of the open stope near the Adit. A stope is an area that was mined while working upwards.

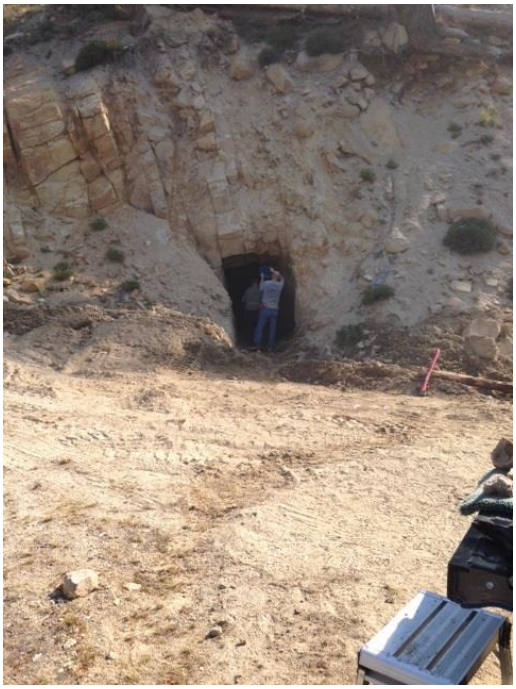
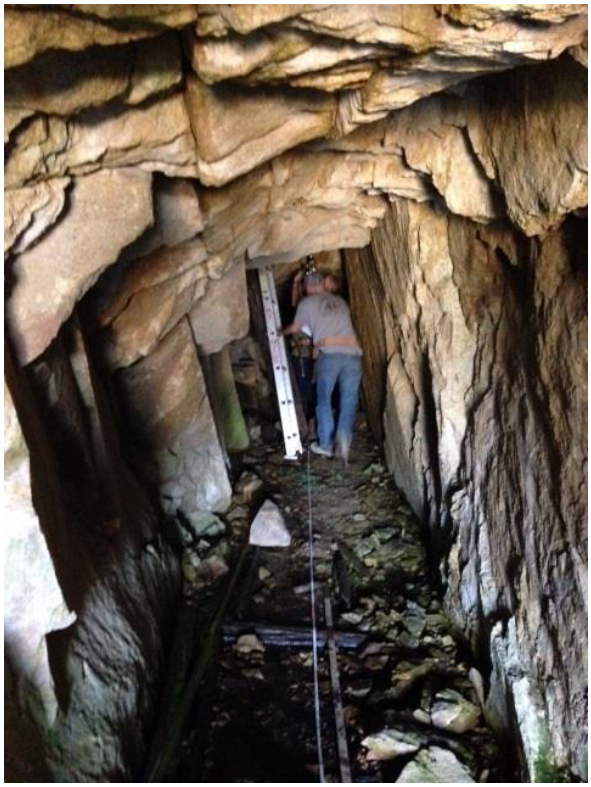
The following photos are of the crew working in the tunnel after debris and water was cleared. The photos with the ladder are of the raise which leads into the first stoop.
